Association of Electrical and Mechanical Trades

GOOD PRACTICE GUIDE

THE REPAIR OF INDUCTION MOTORS

Best Practices to Maintain Energy Efficiency

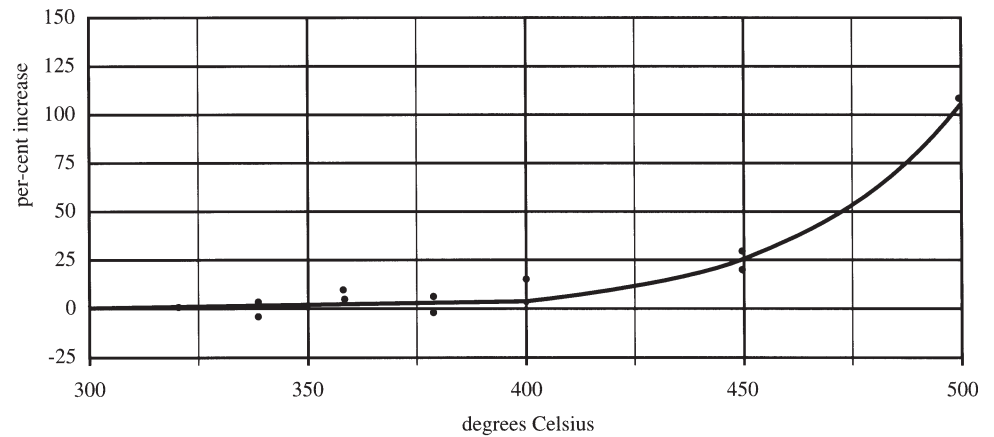
Fig. 11 Effect of burn-out temperature on core losses: old design standard motors.

The results of the tests on the motors with oxide coated laminations are depicted graphically in Figs. 11 and 12. The core losses were virtually unaffected at temperatures up to 360° C, but progressively increased at higher temperatures.

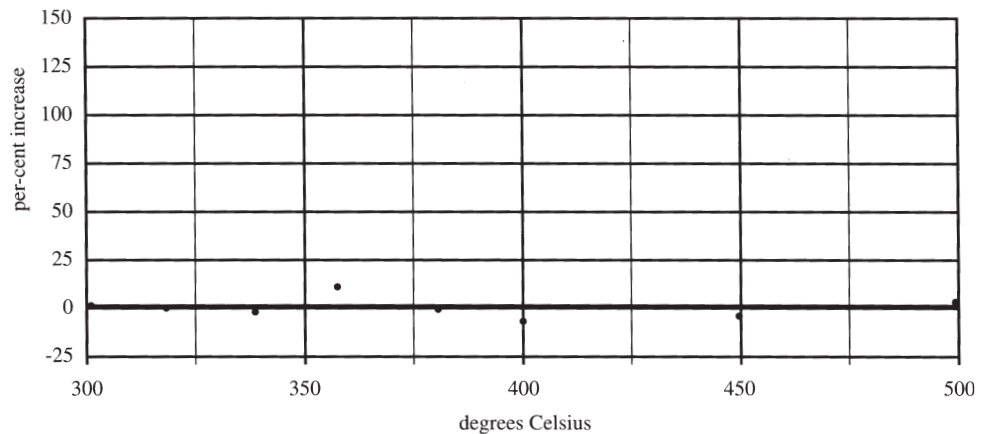
Fig.13 Effect of burn-out temperature on core losses: new “Higher Efficiency” motors.

However, Fig. 13 shows that the new design motors, incorporating the L3 varnish-coated laminations showed no deterioration in core loss, regardless of burn-out oven temperature.
