# GUIDELINES FOR MAINTAINING MOTOR EFFICIENCY DURING REBUILDING

(Note: First published in May 1992; revised in September 1999 by EASA's Technical Services Committee.)

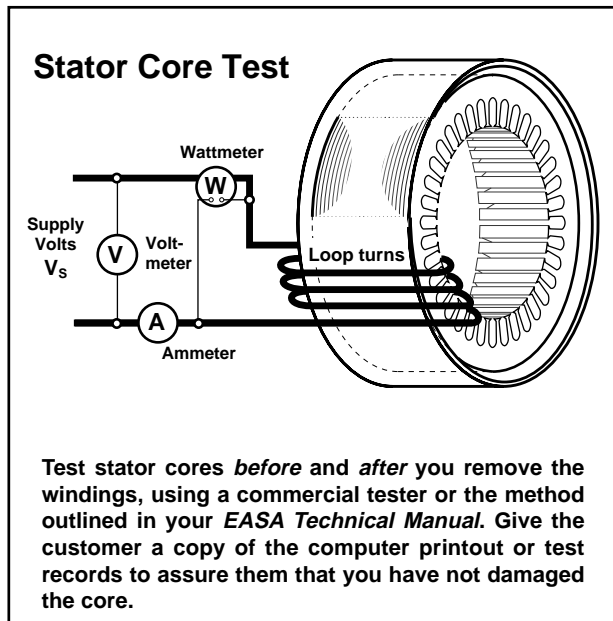
4. **Repair or replace all defective laminations.** Separate all shorted laminations. When restacking a core, use a coreplate varnish on one side of the laminations,

cure the varnish at the recommended temperature, and stack an unpainted side against a dry painted side. If new laminations must be cut, send a sample to your supplier. Be sure to specify that losses in the new laminations must be equal to or less than those of the original laminations. Deburr all new or restacked laminations.
